**PIPELINE INVESTIGATION REPORT
P05H0044**

CRUDE OIL PIPELINE RUPTURE

**TERASEN PIPELINES (TRANS MOUNTAIN) INC.
508-MILLIMETRE-DIAMETER TRANSFER LINE
NEAR ABBOTSFORD, BRITISH COLUMBIA
15 JULY 2005**

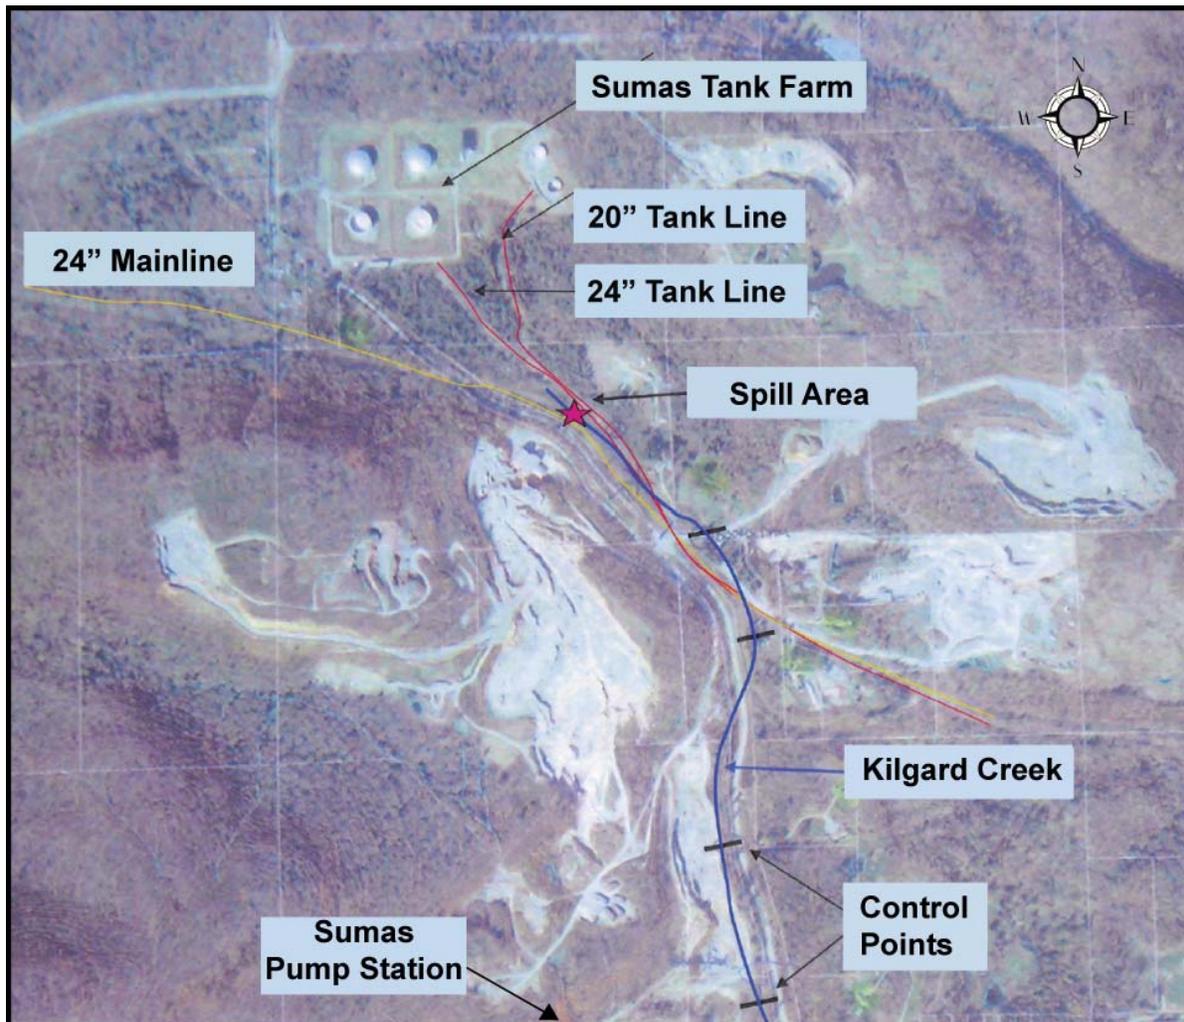
Figure 1. Terasen's mainline pipeline system between the Sumas Pump Station and the Sumas Tank Farm

The movement of crude oil was remotely controlled and monitored by Terasen's control centre operators (CCOs) using a Supervisory Control and Data Acquisition (SCADA) system located at the company control centre (CCC). Crude oil is delivered to and from the Sumas Tank Farm via the Sumas Pump Station located on Terasen's mainline pipeline system (see Figure 1), via two buried pipelines: a 508 mm-diameter line (nominal pipe size of 20 inches) built in 1957 and a 610 mm-diameter line (nominal pipe size of 24 inches) built in 1962. The 508 mm pipeline was constructed with a 6.35 mm (0.250 inch) wall thickness and a pipe grade 359 (American Petroleum Institute grade 5LX-X52).
